# International Boundary and Water Commission

## Nogales Trunkline & IOI Rehabilitation Phases 1-3

Contract Number: 191BWC21C0003  
Contractor: SAK Construction, LLC  
Notice to Proceed (NTP): September 9, 2021  
Substantial Completion: August 14, 2023  
Final Contract Price: \$15,079,300.10

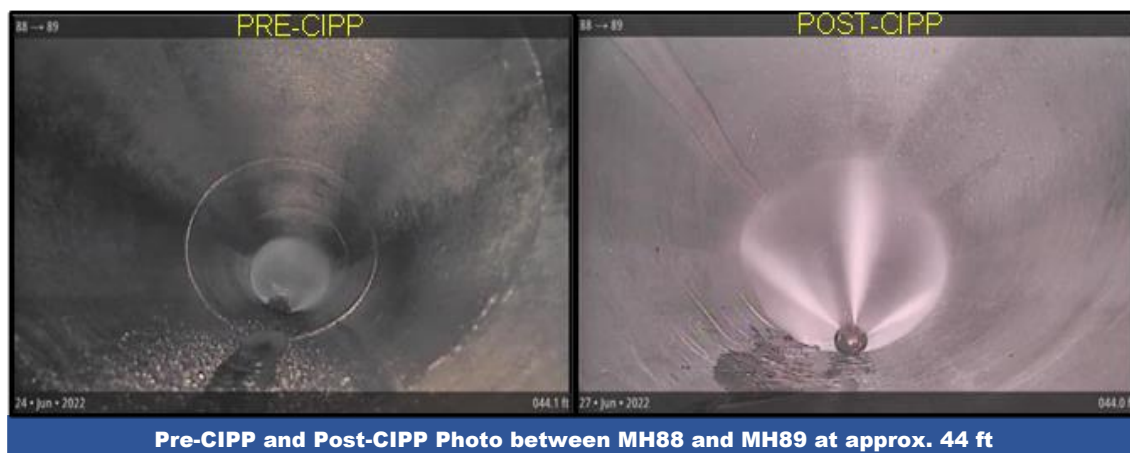
Pre-CIPP and Post-CIPP Photo between MH88 and MH89 at approx. 44 ft

- Rehab of 28,364 LF (5.3 Miles) of piping
- Trenchless technology with little or no disruption to the existing ground conditions
- A resin filled polyester felt tube, or liner, is inserted and inverted into an existing pipe
- The liner is inflated and thermally cured-in-place using hot water

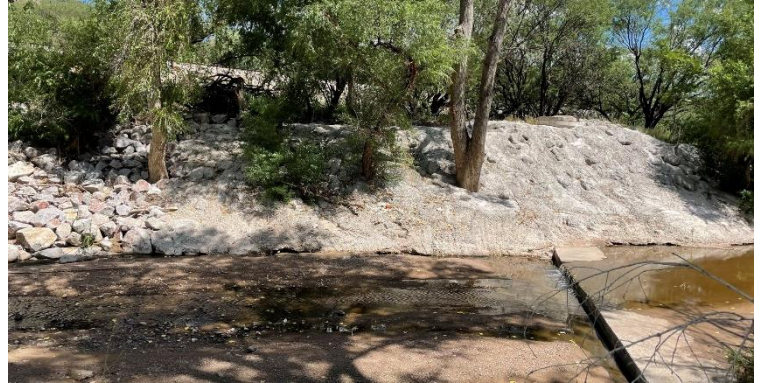
Significant bank erosion of the Nogales Wash occurred adjacent to Manhole 86 including the continuous exposure of the bare pipeline between MH 86 to 87 crossing the Wash. Repairs included:

Slope repair at MH 86 and encased pipe between MH 86-87, 8/14/2023

- Installation of riprap along bank
- Grouting riprap surrounding MH 86
- Concrete encasement of 34 ft of bare pipeline in Wash between Manhole 86-87

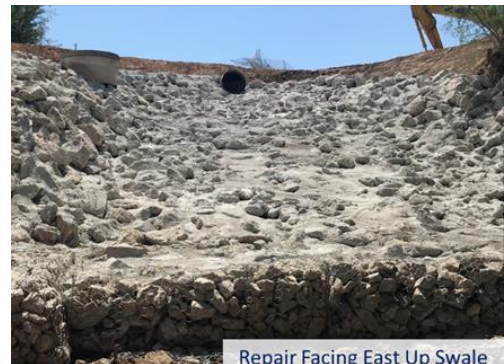
Repair Facing East Up Swale

Drainage from a nearby corrugated metal pipe (CMP) for an adjacent property eroded the entire bank from the IOI MH 93 to the Nogales Wash. Part of the manhole risers were exposed and continued erosion could lead to a collapse of the manhole. Repairs included:

Completed slope repair at MH 93, 6/6/2022

- Installation of riprap to backfill the bank
- Grouting the top of riprap
- Cover for the exposed manhole risers
- Installation of a concrete swale for proper drainage of CMP to Wash
- Gabion installation along Wash

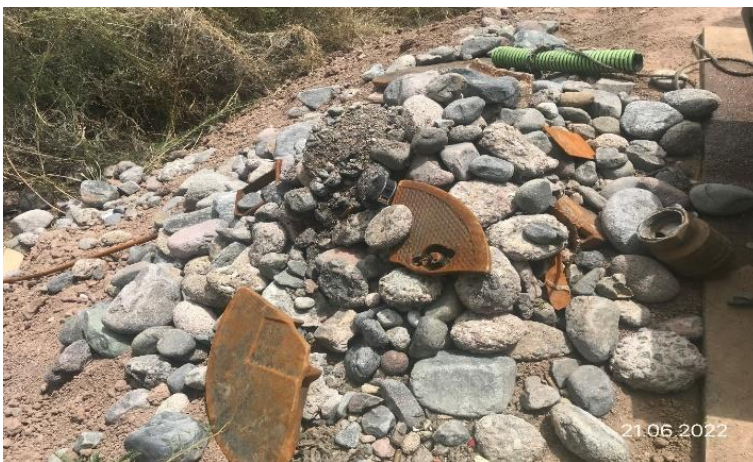
Debris removed from the IOI during Phase 1  
6/21/2022

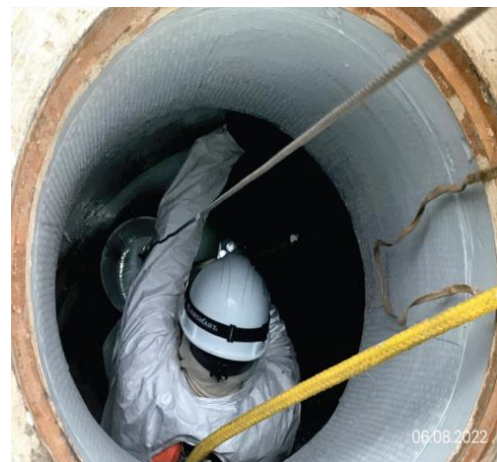
Application of top coating at MH 87  
6/8/2022

- Rehab of 56 manholes
- Majority of manholes rehabilitated with a protective epoxy lining system
- Manholes with structural defects were rehabilitated with a carbon fiber system
